"Failure Avoidance Through Laboratory Testing"

SPECIALTY POLYMER COATINGS, INC.

LABORATORY EVALUATION OF SP8888® SPRAY GRADE COATING

0154-02-04-T

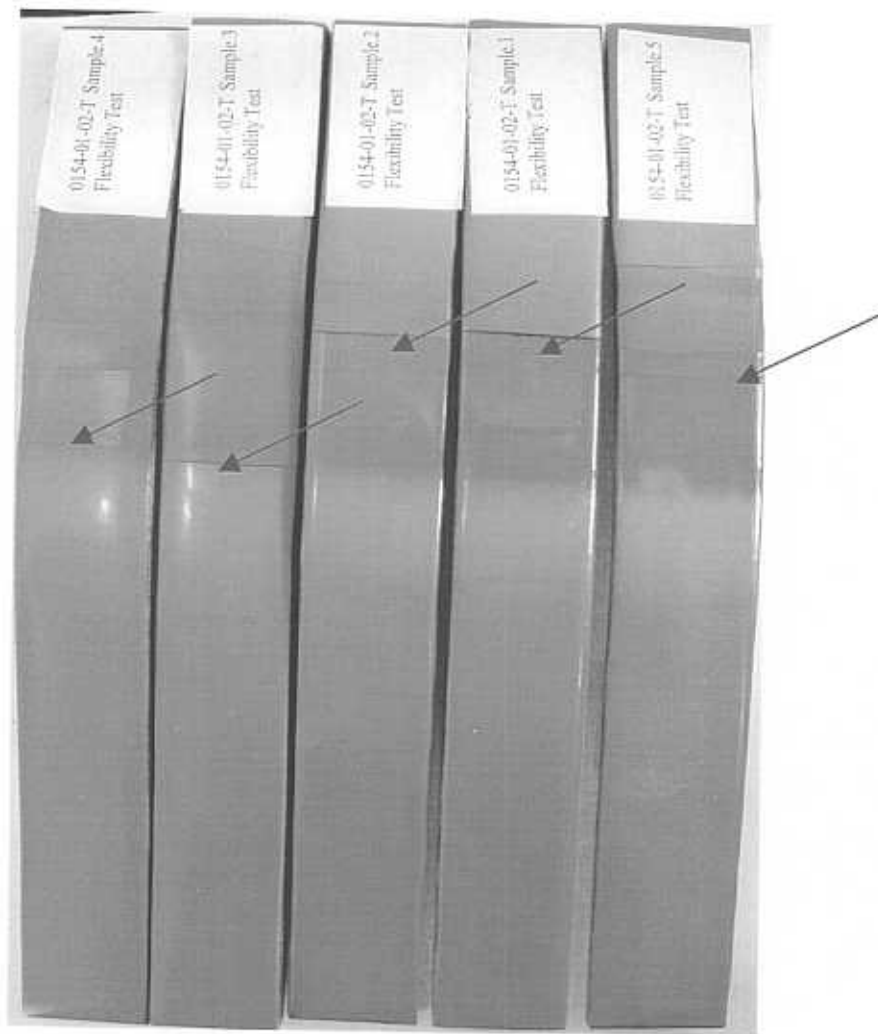
Figure 1. Post-Test Overview – Flexibility Test, 21°C/70°F

The above photograph is the post-test overview of the Bend Test samples at 21°C/70°F. The coating showed no cracks as a result of being bent to an average value of 1.74°/PDL. Cracks occurred as a result of bending to an average value of 2.29°/PDL (blue arrows). All samples were taken to their failure point and the degree of bending was calculated for each one.

- At 21°C/70°F, the Flexibility Test for SP8888® Spray Grade Coating resulted in no cracking or breaking when bent over and above 280 mm radius mandrel size. This radius corresponds to an average value of 1.74°/PDL.
- At 0°C/32°F, the Flexibility Test for the same coating showed no cracking or breaking when bent over and above 414 mm radius mandrel size. This radius corresponds to an average value of 1.03°/PDL.
- At -30°C/-22°F, 66% of the tested samples of SP8888® Spray Grade Coating exhibited no cracking or breaking when bent over and above 414 mm radius mandrel size. This radius corresponds to an average value of 1.02°/PDL.

Sample #	Film Thickness (mils)	Mandrel Size (Radius in mm)	Cracks/Holidays	Pass/Fail	Degree of Bend (°/PDL)*	%Elongation
1	46 - 50	414	No	Pass	1.19	1.18
		280	No	Pass	1.76	1.73
		210	Yes	Fail	2.35	2.30
2	44 - 45	414	No	Pass	1.15	1.14
		280	No	Pass	1.70	1.67
		210	Yes	Fail	2.26	2.22
3	52 - 56	414	No	Pass	1.20	1.21
		280	No	Pass	1.78	1.78
4	38 - 42	414	No	Pass	1.16	1.13
		280	No	Pass	1.72	1.66
		210	Yes	Fail	2.29	2.20
5	38 - 44	414	No	Pass	1.16	1.13
		280	No	Pass	1.72	1.16
		210	Yes	Fail	2.29	2.21

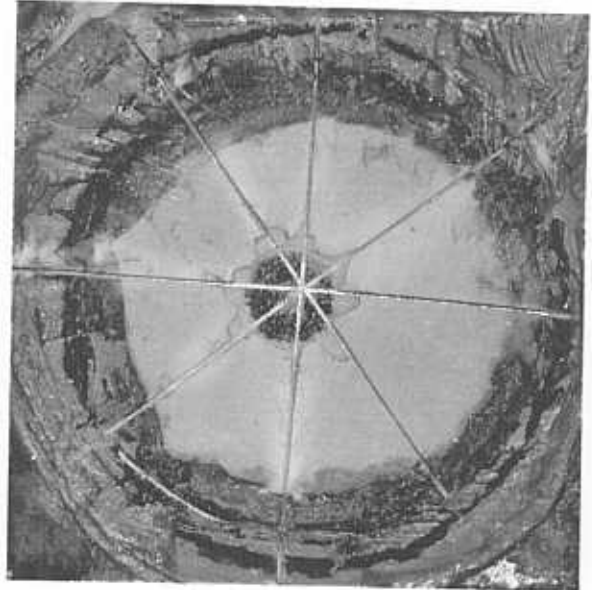
Figure 7. Post-Test Overview - Cathodic Disbondment Test

The above photographs are samples of the Cathodic Disbondment Test after twenty-eight (28) days of testing at 120°C/248°F. The radial cuts intersect the initial holiday. The average radius of disbondment is 4.7 mm, excluding the initial holiday radius. Loss of sheen and chalking was observed as a result of testing.

Test Panel No.	Duration (Days)	Film Thickness (mils)	Average Radius Disbondment (mm)*	Pass/Fail
1	28	33 – 45	3.0	Pass
2		36 – 40	6.36	Pass
